TECHNICAL REPORT 87-7

**CRACKING AND SEATING
PCC PAVEMENT
CONSTRUCTION TECHNIQUES
AND OVERLAY PERFORMANCE
FIRST INTERIM REPORT**

DECEMBER, 1987

**William M. McCarty
Civil Engineer I (Materials)**

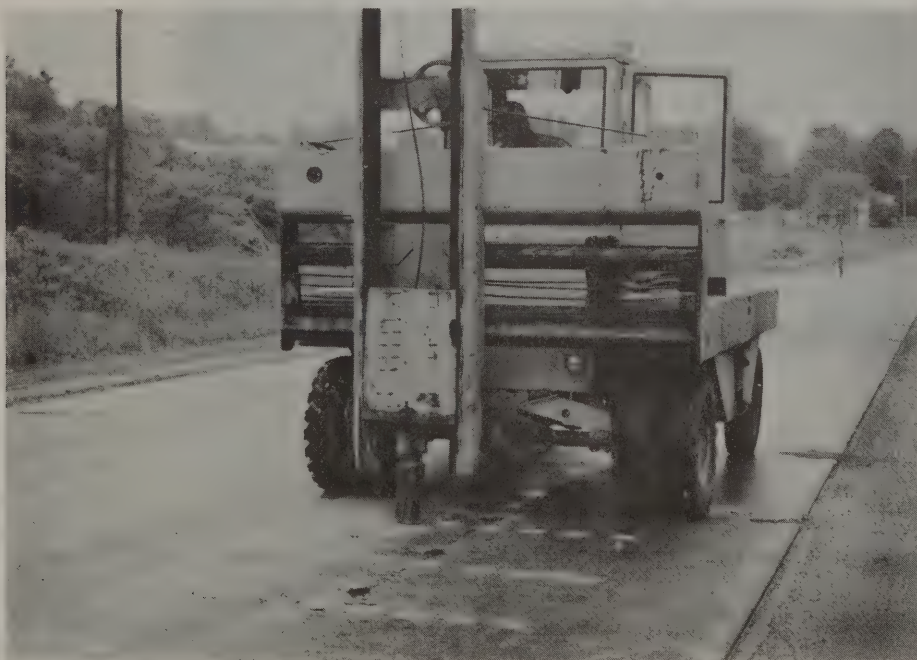
A drop hammer was used to crack the pavement in the designated test area on the contract (Figure 2). One lane was cracked while traffic was being maintained in the other. The pavement breaker was a self propelled unit which dropped a 1200 pound weight from a 4 ft. height. The energy produced was transmitted through a 4 1/2 inch diameter breaking head attached to the bottom of the weight. The operator had the capability of moving the weight across the back of the machine. However, this capability was limited, and a second pass was required in each lane to complete the specified transverse striking pattern. Soon after the contractor began cracking the pavement in the test area, it was discovered that a more desirable crack pattern was easier to achieve if the initial pass began at the unsupported (shoulder) edge and progressed toward the longitudinal joint between lanes rather than beginning near the center of the lane (as shown in Figure 2) or at the longitudinal joint and progressing toward the unsupported edge. It was also found that striking the pavement six inches from the unsupported edge, as specified, often spalled the edge instead of initiating a crack. These experiences led to changes on this project and specification revisions that corrected these inadequacies. The fourth generation specification that evolved appears in Appendix A, (page A9-A10). It was used on the seven other contracts rehabilitated in 1985 and 86.

Figure 2 - Drop
Hammer Used On Rte.
60 (D250877)

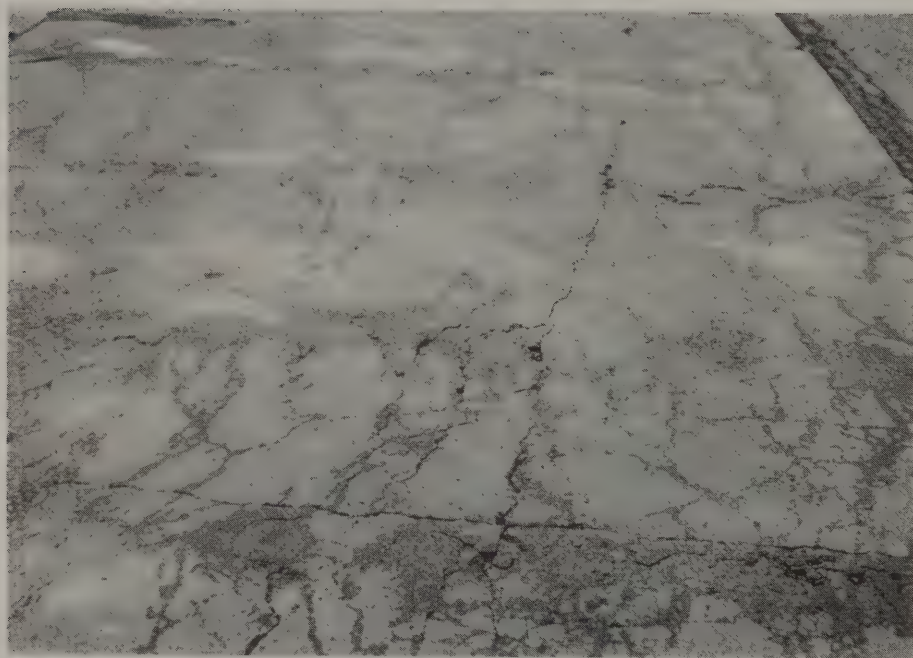
The crack pattern developed by the drop hammer was different than expected. It was thought that positive transverse cracks would initially develop in line with the transverse striking pattern of the machine and that longitudinal cracks would develop as additional transverse striking passes were completed. In most instances, however, just the opposite occurred, with either longitudinal or diagonal cracking occurring first. As cracking continued these cracks linked up to produce irregular transverse cracks. The end result was a crack pattern resembling map cracking (Figure 3). Although the sequence of crack development was not anticipated, definite transverse cracks eventually developed as evidenced by full depth cores (Figure 4). Therefore, the pattern was considered satisfactory and the contractor was allowed to proceed on the remainder of the contract.

Figure 3 - Crack Pattern Achieved With The Drop Hammer

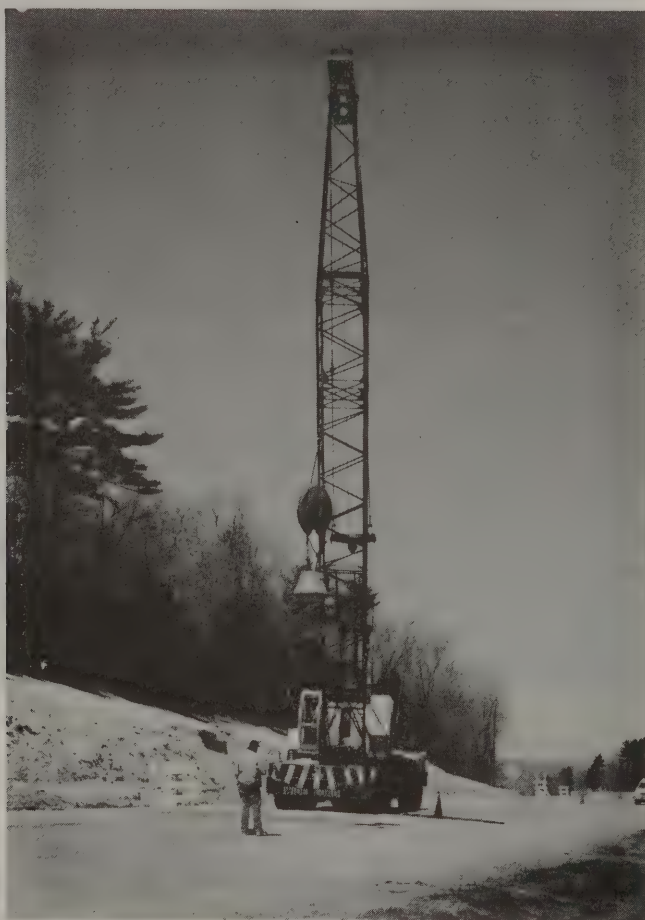
The designated test area on this contract was in the eastbound lanes where a crane equipped with a wrecking ball was used to crack two lanes while traffic was being maintained in the third (Figure 5).

Figure 5 - Crane Equipped With Wrecking Ball Used On Rte. 17 (D250990)

The ability of this equipment to develop the specified striking pattern was solely dependent on the skill and persistence of the equipment's operator in controlling the drop height, orientation, swing and roll of the wrecking ball. This was especially critical when the operator was cracking near the lane being used by traffic. To further complicate this, it was more difficult to satisfactorily crack the center lane which, of course, was supported on either side by the other lanes.

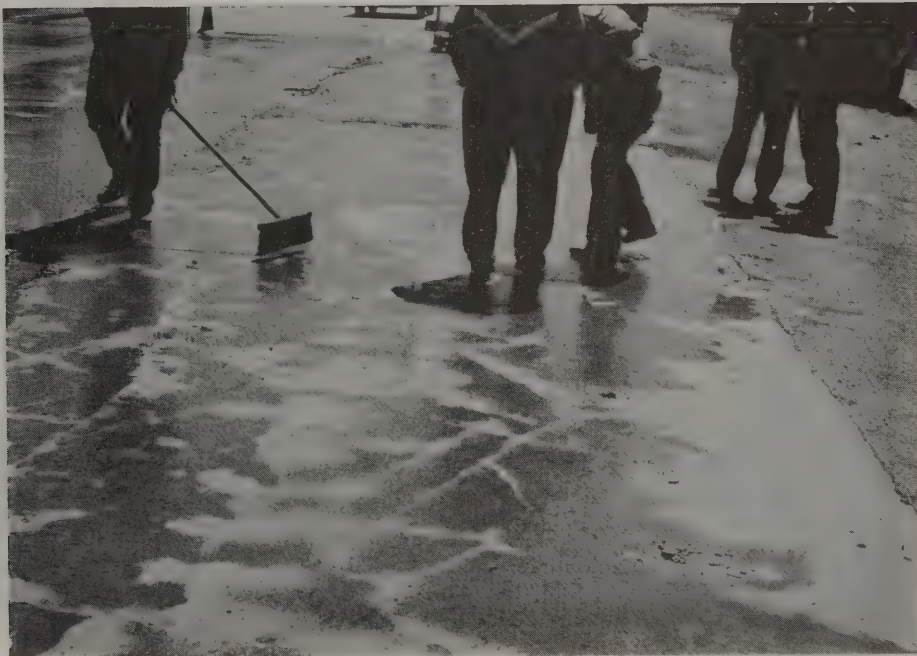
Crack development with this equipment was similar to that on the Rte. 60 contract, longitudinal and/or diagonal cracks appearing before transverse cracking. This resulted in a diamond shaped pattern resembling a chain link fence (Figure 6). As before, this pattern was not what was originally expected but was considered satisfactory since definite irregular transverse cracks eventually developed as evidenced by full depth cores.

Figure 6 - Cracking Pattern Achieved With The Wrecking Ball

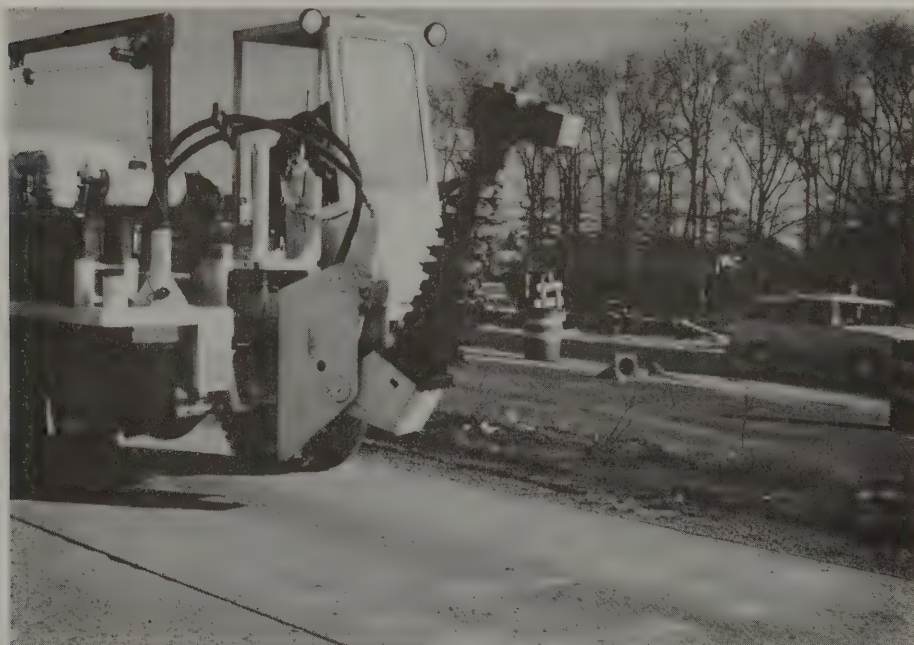
On this highway, one lane was cracked while traffic was maintained in the other. Initially, the contractor opted to use a Whiphammer to crack the pavement in the designated test area (Figure 7). The Whiphammer is a flexible arm made up of leaf springs with a flat, 1 ft. square, cracking head attached to one end. The other end is attached to the back of a truck where the arm is hydraulically raised to its striking position. In addition, the operator can swing the arm in a 7 ft. long transverse arc across a pavement lane. Consequently, two passes are required to complete the specified transverse striking pattern (Figure 8). The Whiphammer strikes the pavement in much the same way an individual would strike a surface with a hand held hammer.

Figure 7 - The Whiphammer Pavement Breaker Similar To That Used On Rte. 15 (D500103)

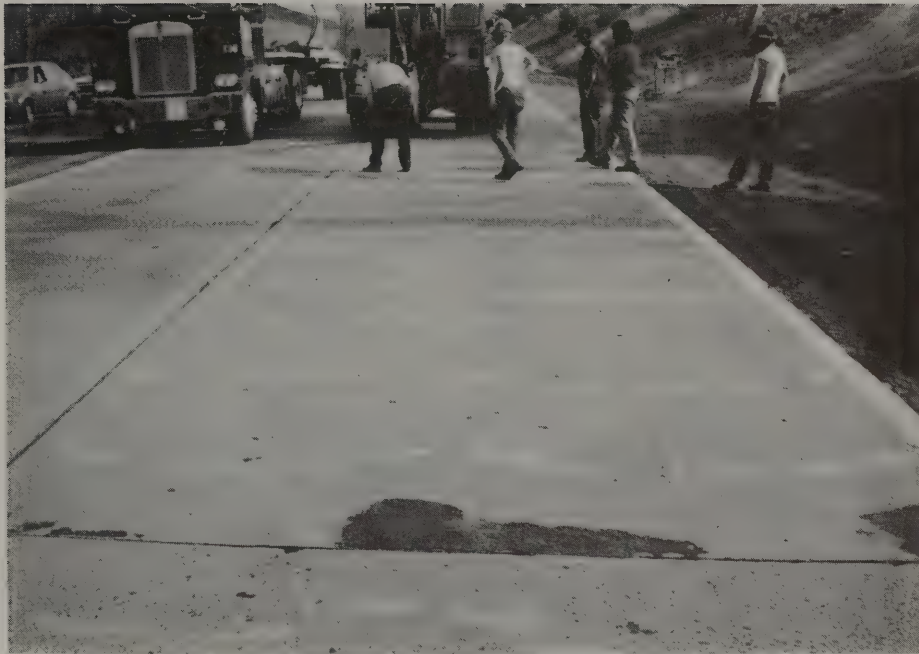
Figure 8 - Resultant Strike Pattern After Second Whiphammer Pass

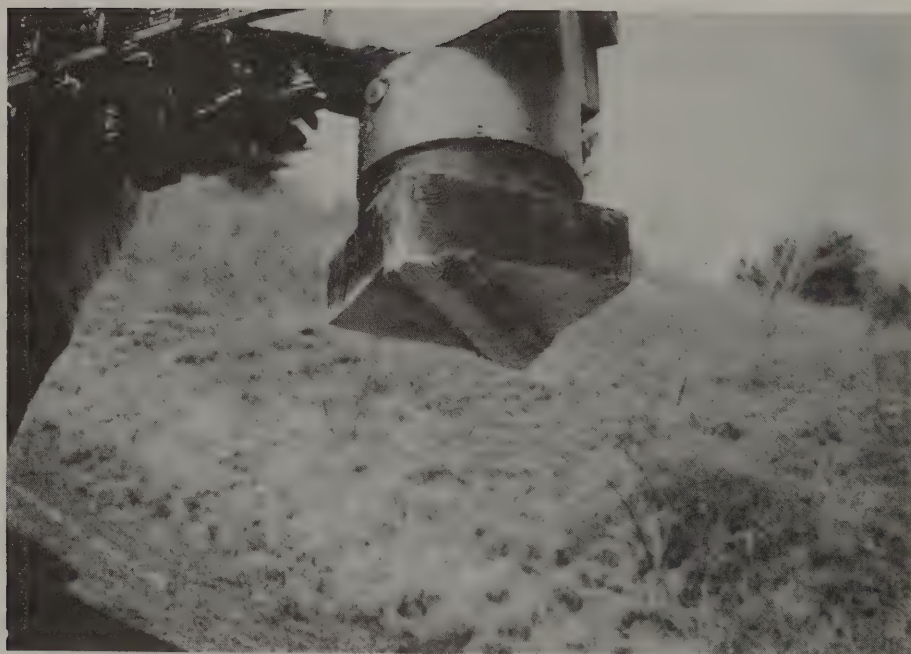
One day was spent unsuccessfully attempting to establish an acceptable crack pattern in the contract's designated test area. Efforts involved the use of three different breaking heads; a worn, foot square steel flat head, a new, foot square steel flat head and a new, foot square steel flat head with a 4 in. X 12 in. steel bar welded to its striking surface which reduced the striking area of the head to the dimensions of the bar. The first two heads were not capable of developing the specified crack pattern. With the third, results were inconsistent. On the second day of cracking the bar on the bottom of the third head was reduced further to 2 in. X 12 in. (Figure 9). This modification produced a satisfactory pattern provided the breaking procedure outlined in the specification was stringently followed. On the third day, however, results were again inconsistent and operations were suspended. Consequently, it was not possible to establish a production rate for this machine.

Figure 9 - Whippammer Breaking Head With Attached Bar

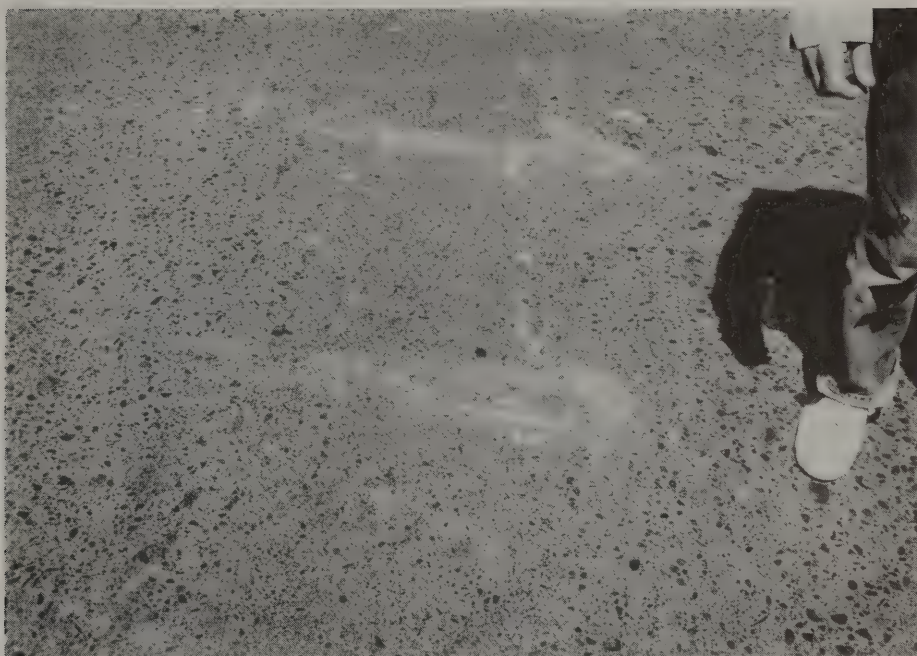
Spalling, resulting from cracking, was minimal except where the weight was allowed to fall directly on a previously damaged or delaminated transverse joint. Minor spalling also occurred on superelevated curves where only one corner of the weight struck the pavement rather than the entire striking surface of the weight (Figure 12). The rest of the pavement on this contract was cracked with the Wirtgen machine and paving was completed before the end of the construction season.

Figure 12 - Minor Spalling That Occurred On Superelevated Curves

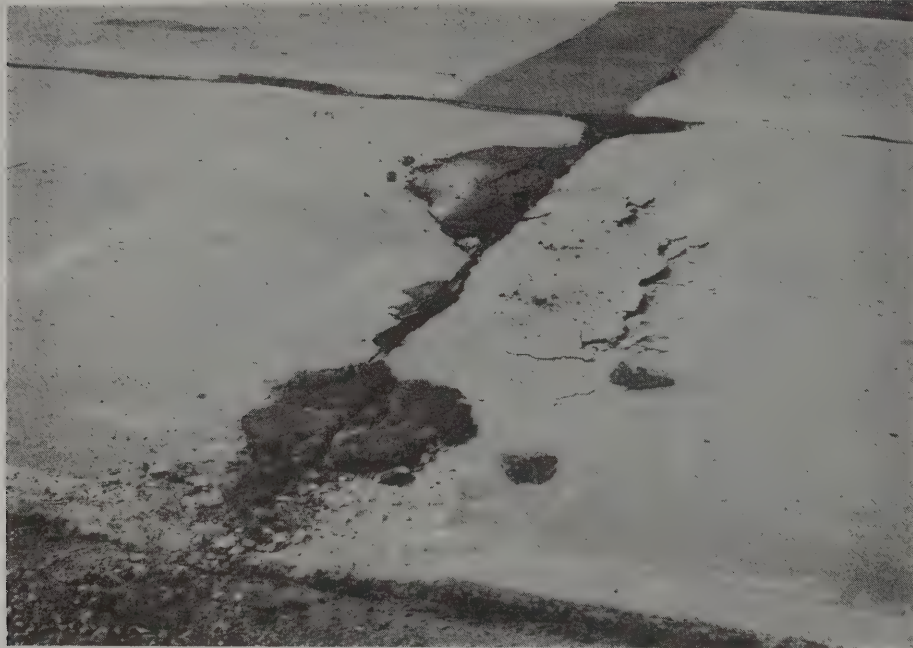
The Wirtgen CB7000 was also used to crack the PCC panels in the eastbound lanes of this contract with results similar to those reported previously. Cores taken to verify full depth cracking revealed the presence of delaminations cracks. Some of the spalling that occurred at transverse joints during cracking was believed to be associated with the presence of these cracks (Figure 14). Spalls had to be repaired with AC before the initial AC overlay course was placed. The eastbound lanes were overlaid before the end of the 1985 construction season. The westbound lanes were not cracked, seated and overlaid until 1986. At that time, a drop hammer was used to crack panels. Since representatives from the Materials Bureau were not present to observe this operation, further evaluation of the westbound lanes was discontinued.

Figure 14 - Spalling At A Transverse Joint Believed
To Be Associated With Delamination Cracks

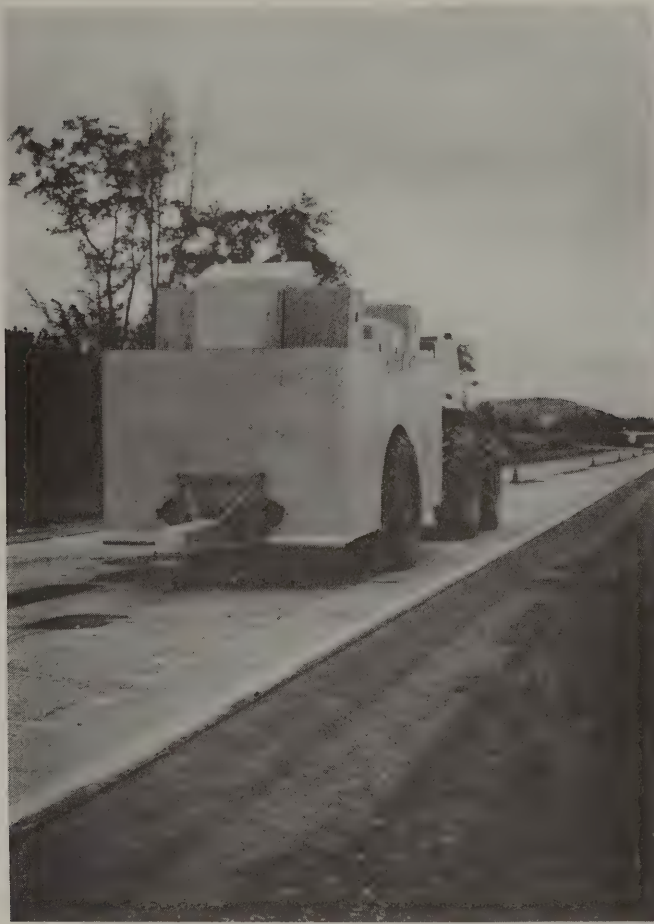
Figure B1 - Typical
Seating Operation With A
50 Ton Roller
